CITY OF BALTIMORE WET SMOKE AND DYED I	Page 1 of 3		
Sewershed: Low Level Subsewershed: 44	Company: REI/DRAYCO	Date: 09/03/2008	
Test Type: Smoke	Ground Condition: Dry: X Damp:_ Wet:_	Supervisor: E.R. Crew: 04	
Manhole ID: S19K031MH	Test ID: 1029-596	Notifications Made:X Residents, Fire, 311

CITY OF BALTIMORE SMOKE TESTING OBSERVATION SUMMARY LOW LEVEL SEWERSHED

BALTIMORE CITY PROJECT 1029 REI/DRAYCO

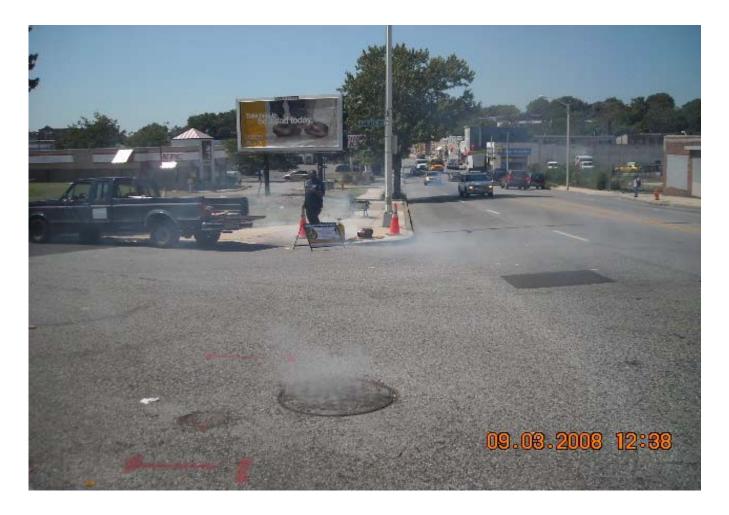
Photograph No: OB01-01 Filename: 1029-596_OB01-01.jpg

Unique Test ID: 596	Date: 09/03/2008	Basin: LL - 44	Manhole ID: S19K031MH
Defect No: OB01 Supervisor	:: E.R. Crew: 04		Dye Test Recommended: N
Location: S19K045MH			
Source Type: 18 Other	Sector: 0	1 Public	
Location: 14 Other	Severity: 0	3 Moderate	Drainage Area: 25
Comments: MANHOLE S19K	045MH HAS STORM DF	RAIN LID.
